MISCELLANEOUS PAPER S-73-46

CONDITION SURVEY, PLATTSBURGH AIR FORCE BASE, NEW YORK

June 1973

Conducted by U. S. Army Engineer Waterways Experiment Station
Soils and Pavements Laboratory
Vicksburg, Mississippi

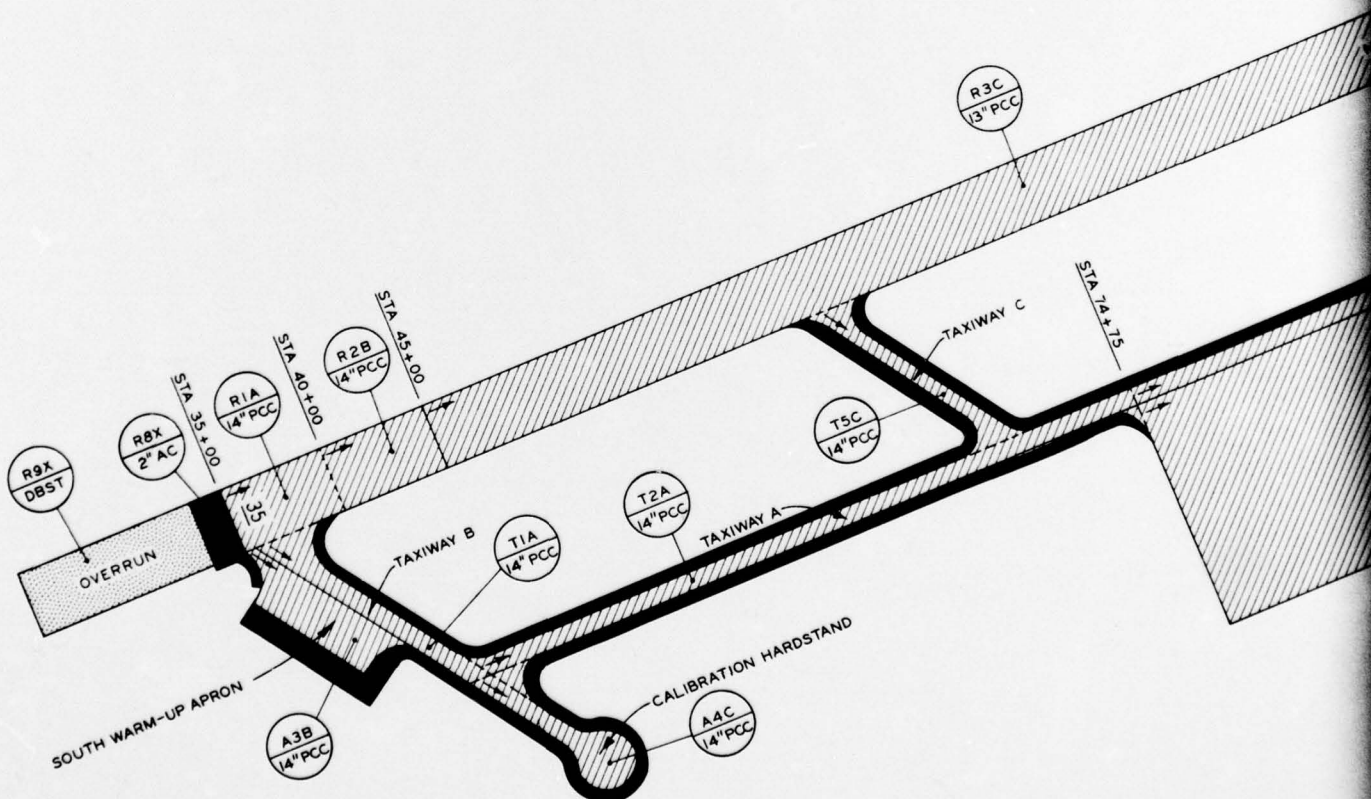
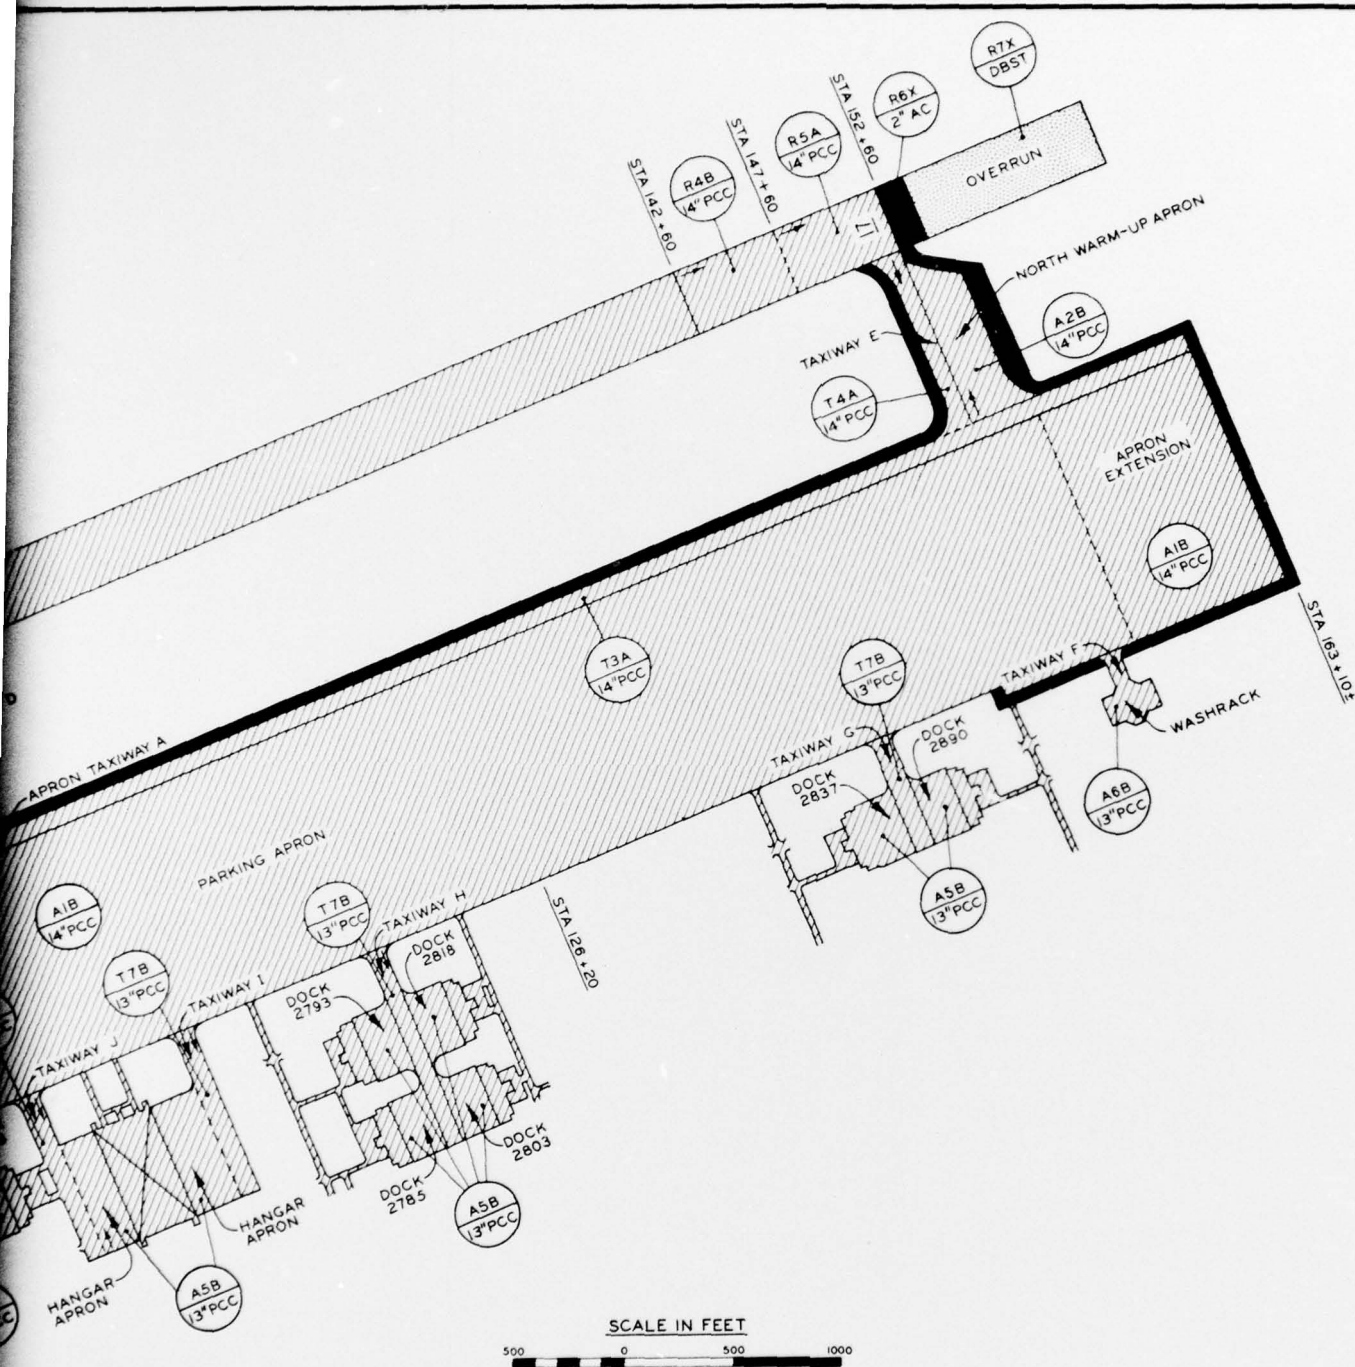
AIRFIELD LAYOUT AND PAVEMENT PLAN

9. The following procedure was used in conducting the inspection of the rigid pavements. Representative features were selected for detailed inspection. The features were then inspected slab** by slab, and the defects were recorded. The locations of the individual pavement features, the inspection starting points, and the directions in which the pavements were inspected (shown by arrows) are indicated in plate 1.
